Field Report for Airborne Data Collected In Support of US EPA Region VI International Terminal Corporation Fire 18 March 2019

Mission: 2019-03-18 Houston Refinery Fire

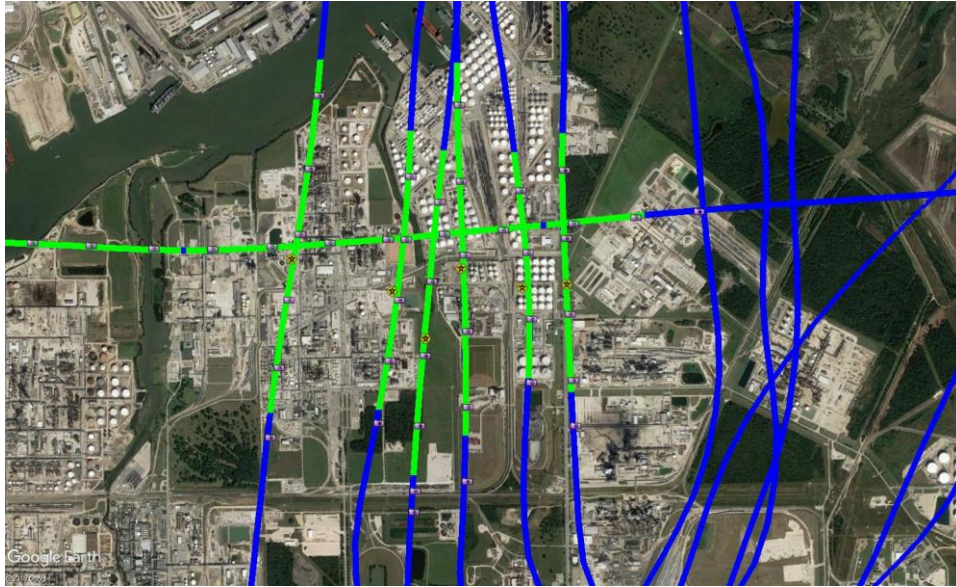
Figure 2: Data collection passes, International Terminal Corporation Fire, Deer Park, TX. The blue lines represent the ASPECT flight path, green lines represent when the Infrared Line Scanner was actively collecting data, and the camera icons represent when a photo was taken.

The order to launch the aircraft was given at 1000 local on 18 March 2019 and the aircraft was airborne at 1055. The initial data collection run over the site was at 1252 (local) The aircraft made a total of seven data collection passes; flight information is summarized in Appendix A and Figure 2.

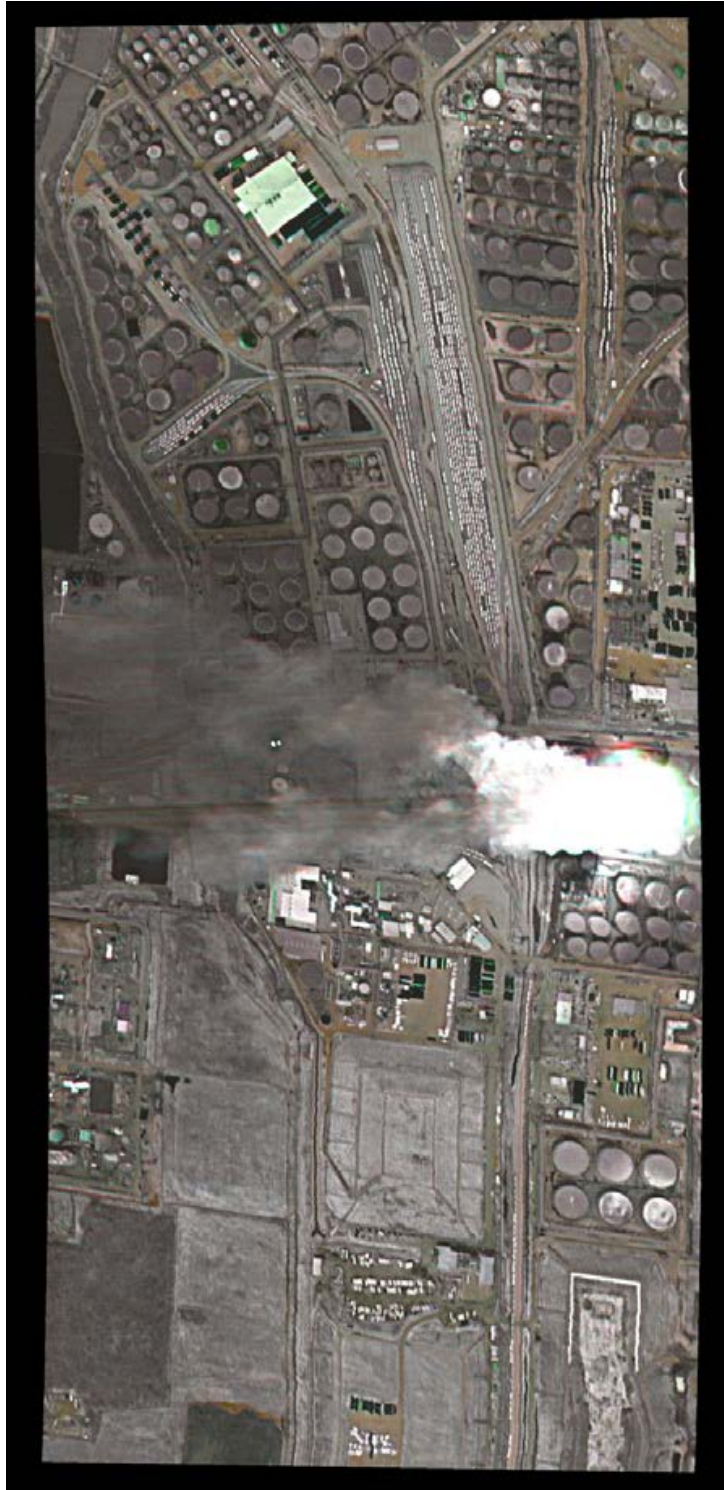
A total of 1 test and 7 data passes were made in the proximity of the site and an infrared line scanner images were generated for each pass. Figure 3 shows a typical 3-band infrared image obtained from data collected for Run 5. The image clearly shows that the fire is very intensive and is not only generating a hot target (as white) but is also producing an extended plume of hot air as the plume moves to the west. An examination of the area to the west shows almost total obscuration most likely due to particulate loading of the plume and to a certain extent thermal masking of the surface signal.

Figure 3: – 3 band IR image, Run 5, International Terminal Corporation Fire, Flt 2

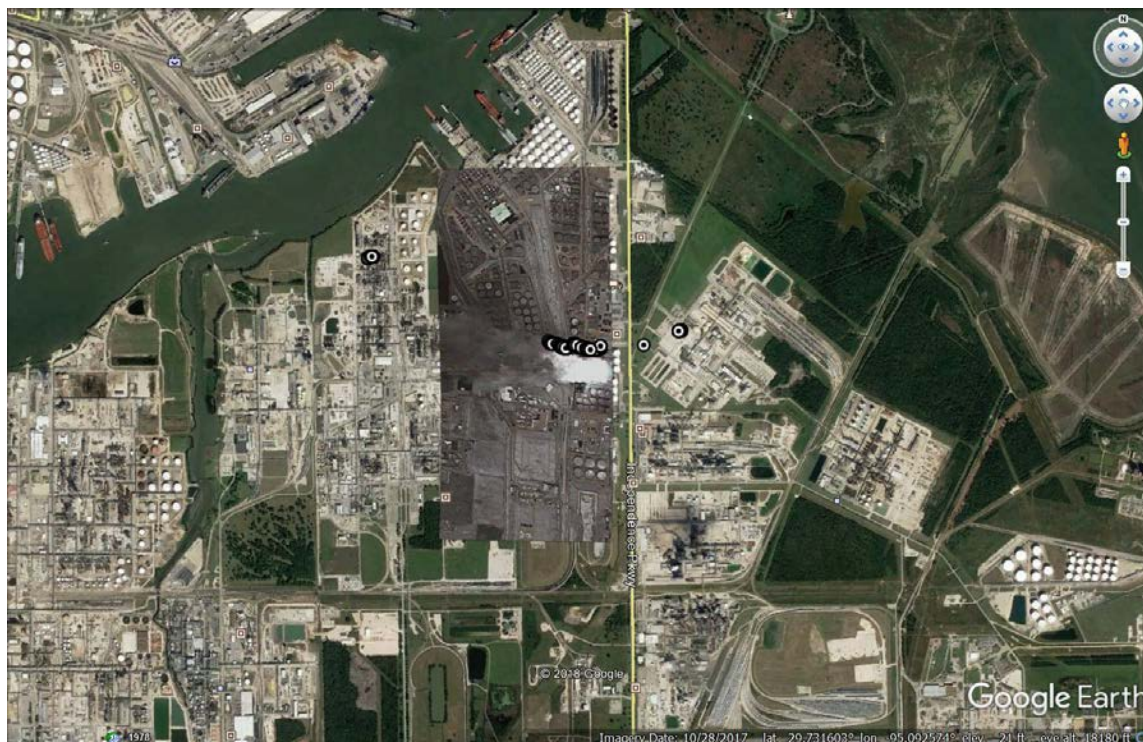
Spectral examination of the fire showed more detections than on the afternoon/evening of 17 March 2019. Figure 5 shows the where individual compounds were detected in relationship to the fire. Most of the compounds detected were made on the northern side of the fire. Compound detections east of the fire are most likely native compounds present in the urban air.

Figure 5: Chemical detections as denoted by dots on the image.

Table 3 list the compounds detected and the maximum concentration estimated from the FTIR data. These detections are very low with the highest being just above 1 ppm. It should be noted that based on the plume structure and height, it is probable that most/all of the detected compounds near and/or generated by the fire are several hundred meters in altitude.

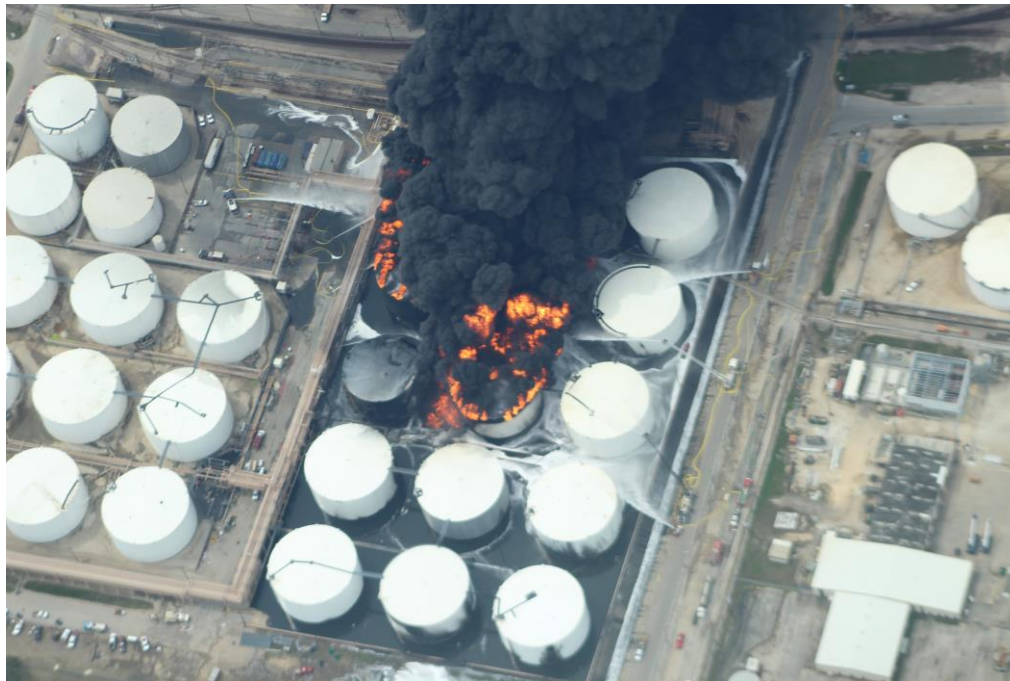
A full set of high resolution aerial digital photography were collected as part of the flight. Figure 6 shows a representative image collected as part of each pass. As discussed in the IRLS Figure 7 shows a representative oblique collected from the copilot station. This image clearly shows the presence of fire in the center tank with additional fire surrounding the tank. The fire is generating a large amount of smoke which is rising nearly vertical. The low light conditions of the image are a result of the plume shading the area as the aircraft passed over the site.

Figure 7: Oblique Image of the International Terminal Corporation Fire, Flt 2
